AERONAUTICAL ACCESSORIES, INC.

ALERT SERVICE BULLETIN ASB No. AA-06107

PC Safety Valve™: Valve Stem Over Torque
Valve Assembly part numbers installed in accordance with
STC's SE5511NM, SE00327AT, or SE00057AT:
P/N 250-954-101 ,101M ,102 ,102M ,105 ,106
P/N 250-958-205
Valve Assembly part numbers installed in accordance with
STC SE00328AT:
P/N 650-852-401 ,402
Valve Assembly part numbers installed in accordance with
STC SE00585AT:
P/N 053-954-101M ,201 ,203
Valve Assembly part numbers installed in accordance with
STC SE02170AT
P/N 610-853-101

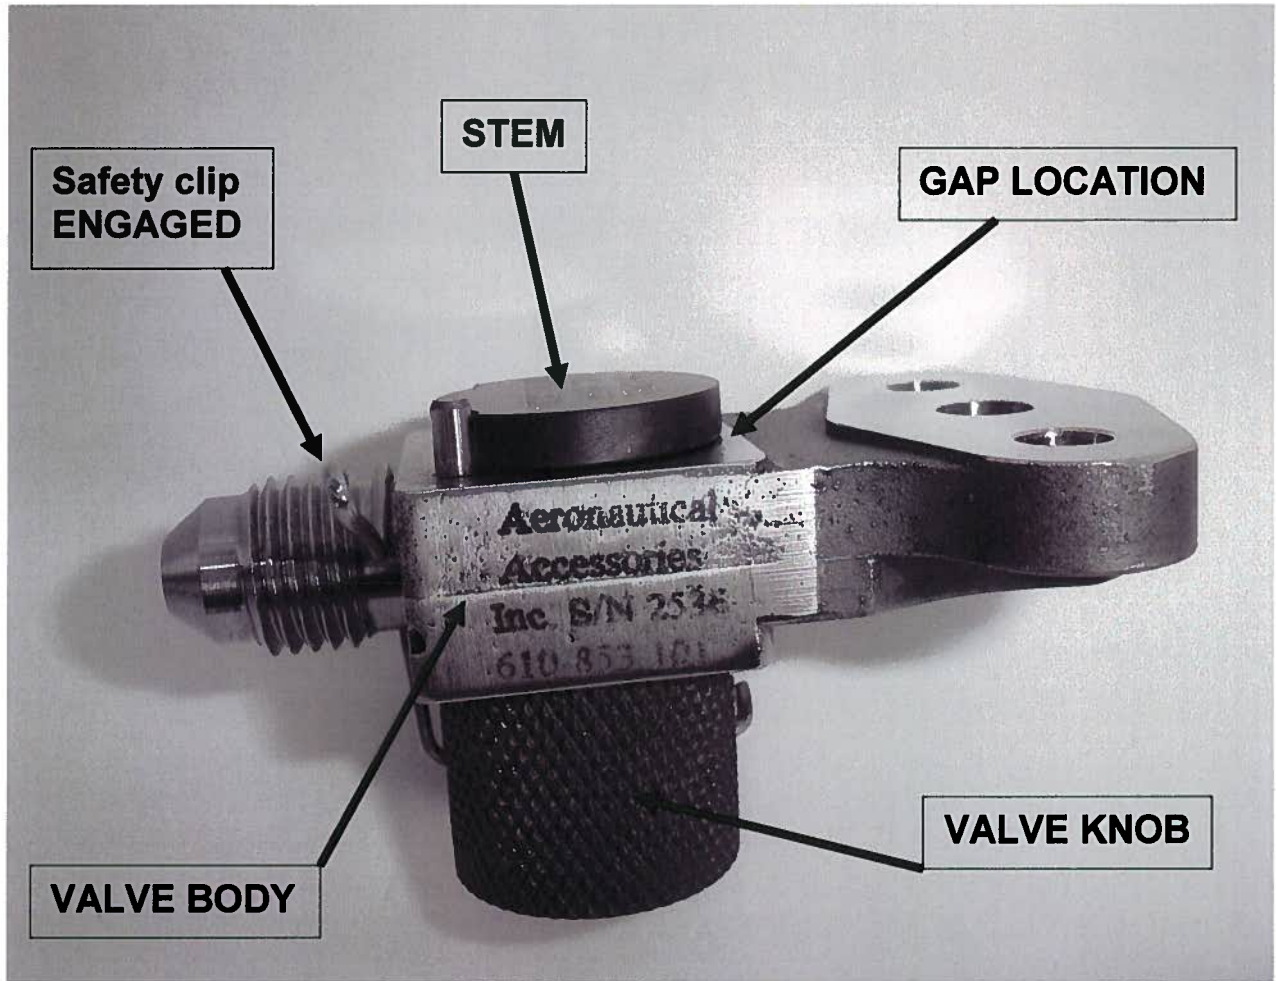
FIGURE 1 – P/N 610-853-101 IN OPEN POSITION

1. Open cowling / panel to gain access to the engine compartment.
2. Locate PC Safety Valve™ assembly on the outside of the engine case.
3. Identify location of the stem. (Reference Figure 1, part removed for clarity)

7. Inspect the gap between the tip of the stem and the valve body opposite the knob (reference Figure 1). The gap between the stem and the valve body should be a maximum of .017 inches. Use a standard feeler gage to determine the actual gap distance (reference Figure 2). Any gap measurement greater than .012 inches warrants closer inspection to determine if the stem has been compromised. If the gap exceeds .017 inches, the valve stem has been compromised and the unit should be immediately returned to Aeronautical Accessories, Inc. for repair.

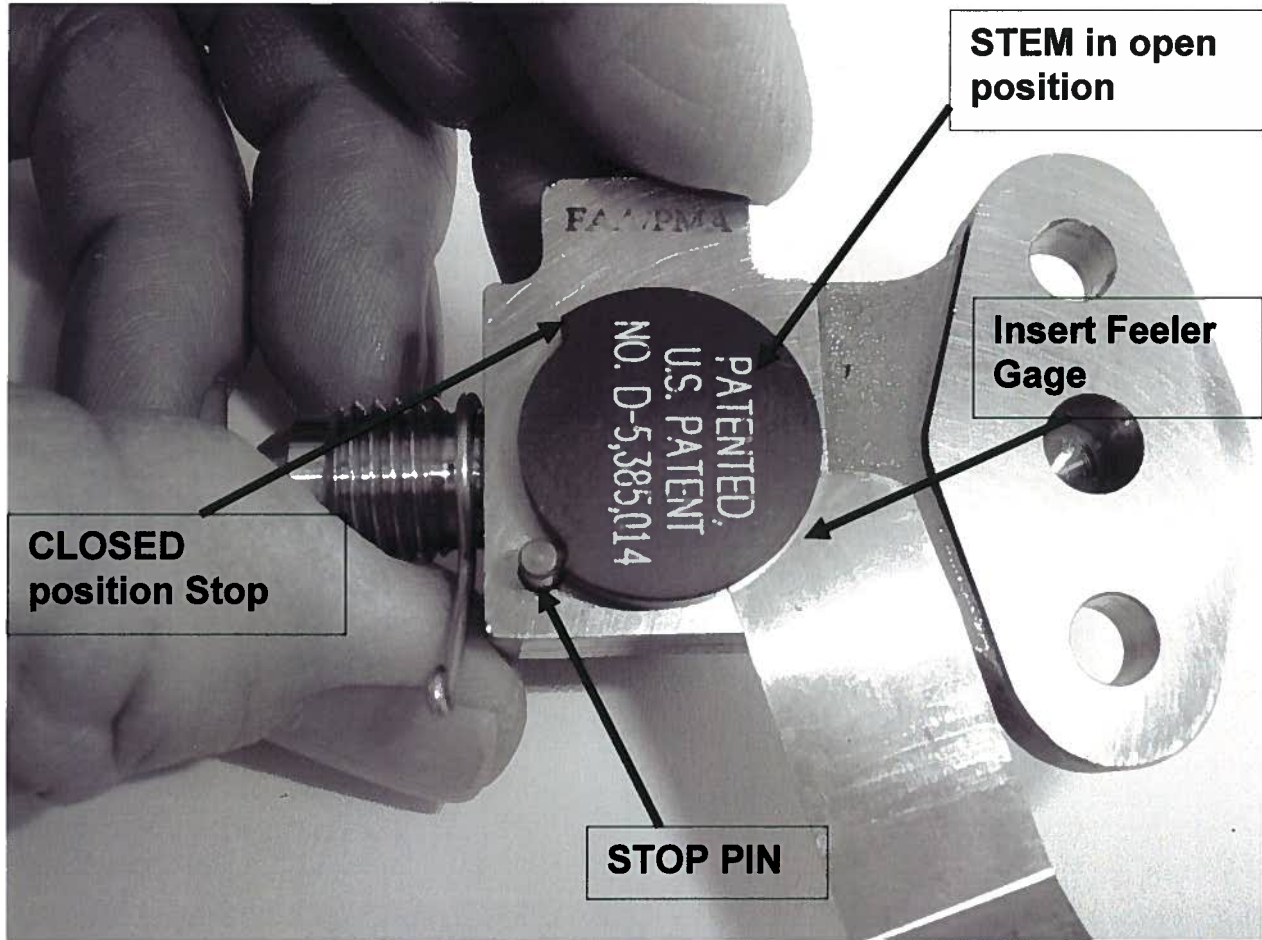
FIGURE 2 – P/N 610-853-101 IN OPEN POSITION (STOPS VISIBLE)

4. Remove safety wire or clip as appropriate.
5. While manually turning the knob from stop to stop, visually or by touch, verify that the opposite end of the stem to which the knob is attached rotates in unison with the knob. There should be distinct stops at both ends of travel (reference Figure 2). If distinct stops at both ends of travel are not detected, the valve stem has been compromised and the unit should be immediately returned to Aeronautical Accessories, Inc. for repair.
