# **AERONAUTICAL ACCESSORIES, INC.**

## **ALERT SERVICE BULLETIN** **ASB No. AA-06025**

**SUBJECT:** **Replacement Handle Kit**  
P/N 407-564-033 / 407-564-034

**MODELS AFFECTED:** Bell Helicopter Textron Model 407 with  
Aeronautical Accessories, Inc.  
P/N 407-564-101 / 407-564-102  
Passenger Photo Window Assembly installed  
in accordance with STC SR09324RC or  
STC SR09324RC-D.

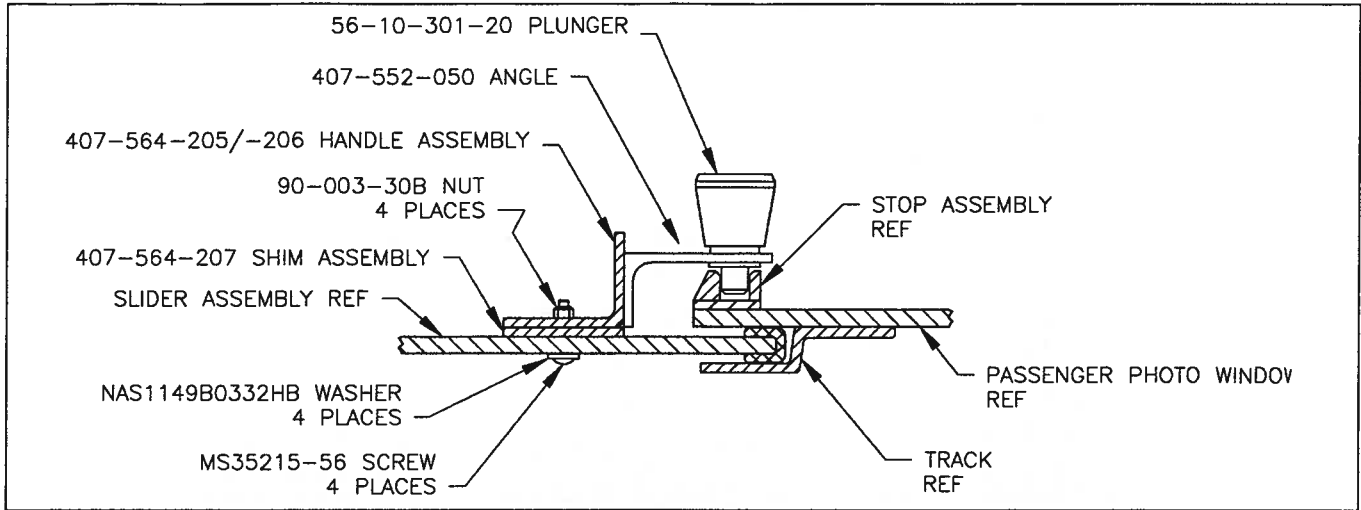
**FIGURE 1 – HANDLE ASSEMBLY INSTALLATION**

**DESCRIPTION:** This Alert Service Bulletin is being issued in  
response to reports of Passenger Photo Window  
Slider Assemblies becoming dislodged from their  
tracks and departing the aircraft while in flight.

5. Install the Shim Assembly and Handle Assembly on the Slider Assembly with hardware, as shown in Figures 1 and 2.
6. Install the Plunger (56-10-301-20) into the Angle (407-552-050) using Adhesive (099-050-171), as shown in Figure 1.
7. With the Slider Assembly in the full-closed position, center the Angle assembly on the Handle Assembly.
8. Ensuring proper engagement of the Plunger inside the Stop, transfer the hole pattern from the Angle to the Handle Assembly (Ref. Figure 2).
