ALERT SERVICE BULLETIN ASB No. AA-06179

Revision A

Emergency Pushout Window

Bell Helicopter Textron model 407 with

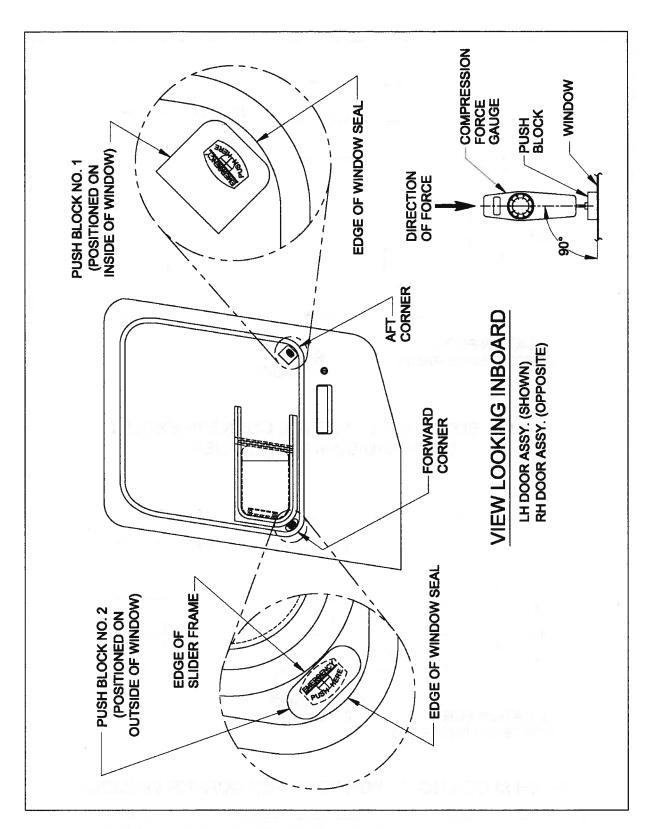
FIGURE 3 - PUSH BLOCK POSITIONS FOR INITIAL EVALUATION

Observe the relationship between window and seal and the seal and the window frame as pressure is applied. Continue applying force until the corner edge of the window barely breaks past the edge of the seal on the inside of the same corner. The window should begin to dislodge from the seal when 45 - 60 lbs force is applied. If window begins to dislodge when 45 - 60 lbs force is applied, stop applying pressure and proceed to Step 5. Otherwise continue with Step 3.

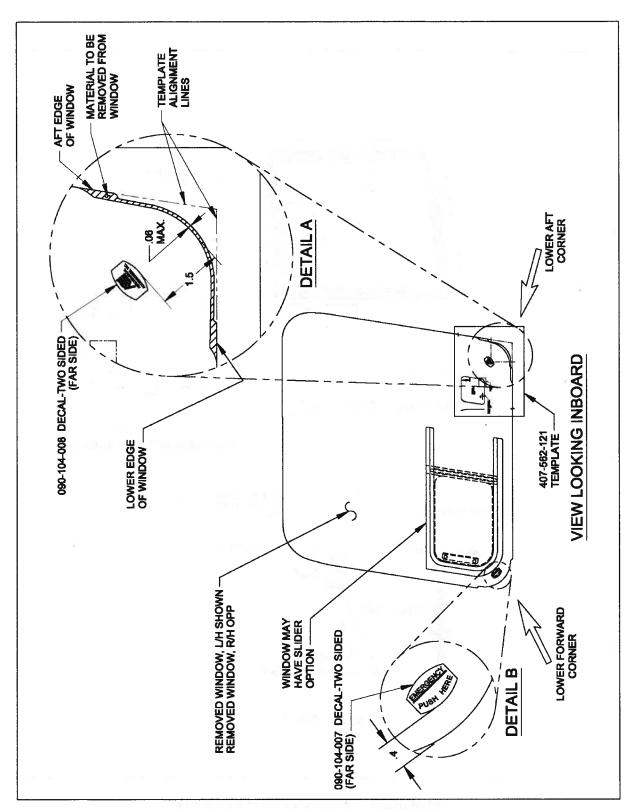
FIGURE 4 – WINDOW MODIFICATION

Verify the amount of window material that extends past the radial portion of the template radius does not exceed .06 inches (ref. Figure 4 – Detail A).

1. Carefully lay the window on a horizontal work area that will not scratch or damage the surface. Orient the Template (407-562-121) in the lower aft corner of the window by aligning the alignment lines on the template with the aft and lower edges of the window, as shown in Figure 4 – Detail A.

2. Mark the new corner profile from the template onto the surface of the window with a fine tip felt marker. Remove excess window material according to the new profile, using a medium grit abrasive pad (80 – 100 grit).

- 1. Remove existing "Emergency Push Here" decals (090-104-002) from the lower, inside corners of the window. Remove all remaining adhesive from the window using isopropyl alcohol.
- 2. Apply Decal Two Sided (090-104-007) to the forward lower, inside corner of window as shown in Figure 4– Detail B. Apply Decal Two Sided (090-104-008) to the aft lower, inside corner of window as shown in Figure 4 Detail A.
- 3. Window decal replacement complete.

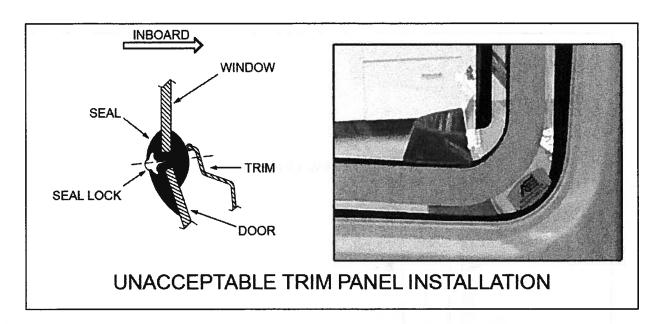
- 1. If installed, verify the upper interior door trim panel does not overlap the seal more than 50% (see Figures 7 and 8). If the overlap exceeds 50%, remove the upper interior door trim panel and trim the material until the overlap on the seal is less than 50%. Reinstall the upper interior door trim panel before proceeding.
- 2. From the lower outside forward corner of the window, gradually apply force, perpendicular to the window, to the center of the "Emergency, Push Here" decal that is located in that corner (see Figure 3).

FIGURE 7 – UNACCEPTABLE PANEL INSTALLATION (Interior panel overlaps more than 50% of seal)

- 15. Remove all masking tape and allow sealant to cure for a minimum of 24 hours at 75 degrees Fahrenheit (24 degrees Celsius).
- 16. Reinstall upper interior door trim panel, if previously removed, ensuring the inside edge of the upper interior door trim panel is adequately trimmed for seal to function correctly. A minimum of one-half of the seal flange width must be exposed around the perimeter (see Figures 7 and 8).

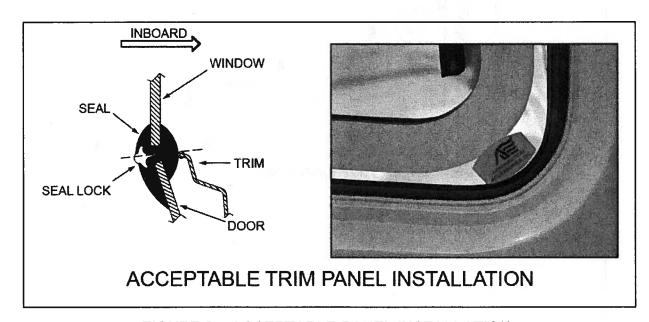
FIGURE 8 – ACCEPTABLE PANEL INSTALLATION (Interior panel overlaps less than 50% of seal)
