# AERONAUTICAL ACCESSORIES, INC.

## ALERT SERVICE BULLETIN

### ASB No. AA-06066

**SUBJECT:** Flat Crew Window  
P/N 206-202-103 / 206-202-104 / 206-202-001 / 206-202-002

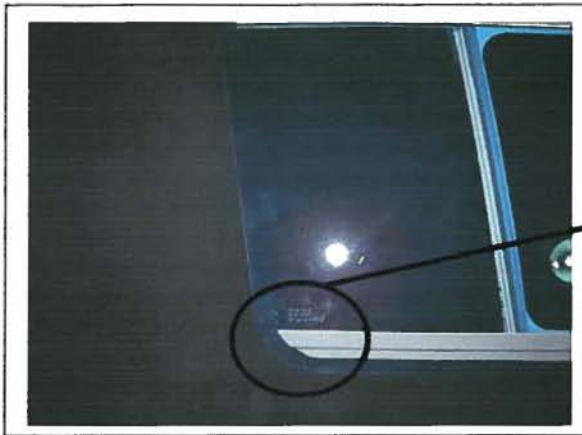
**FIGURE 1 – Identification**

**COMPLIANCE:** Immediately upon receipt of this bulletin, determine by part number, serial number, and manufacture date (ref. Figure 1) if affected window(s) is (are) installed. Only those serial numbers listed are affected. A part with a serial number that is close to, or has a serial number prefix different from those listed is not affected by this bulletin. For installed windows, conduct Part I visual inspection within 8 hours; conduct Part II inspections within 24 hours. For uninstalled windows, accomplish Part I and Part II prior to installation on a helicopter.

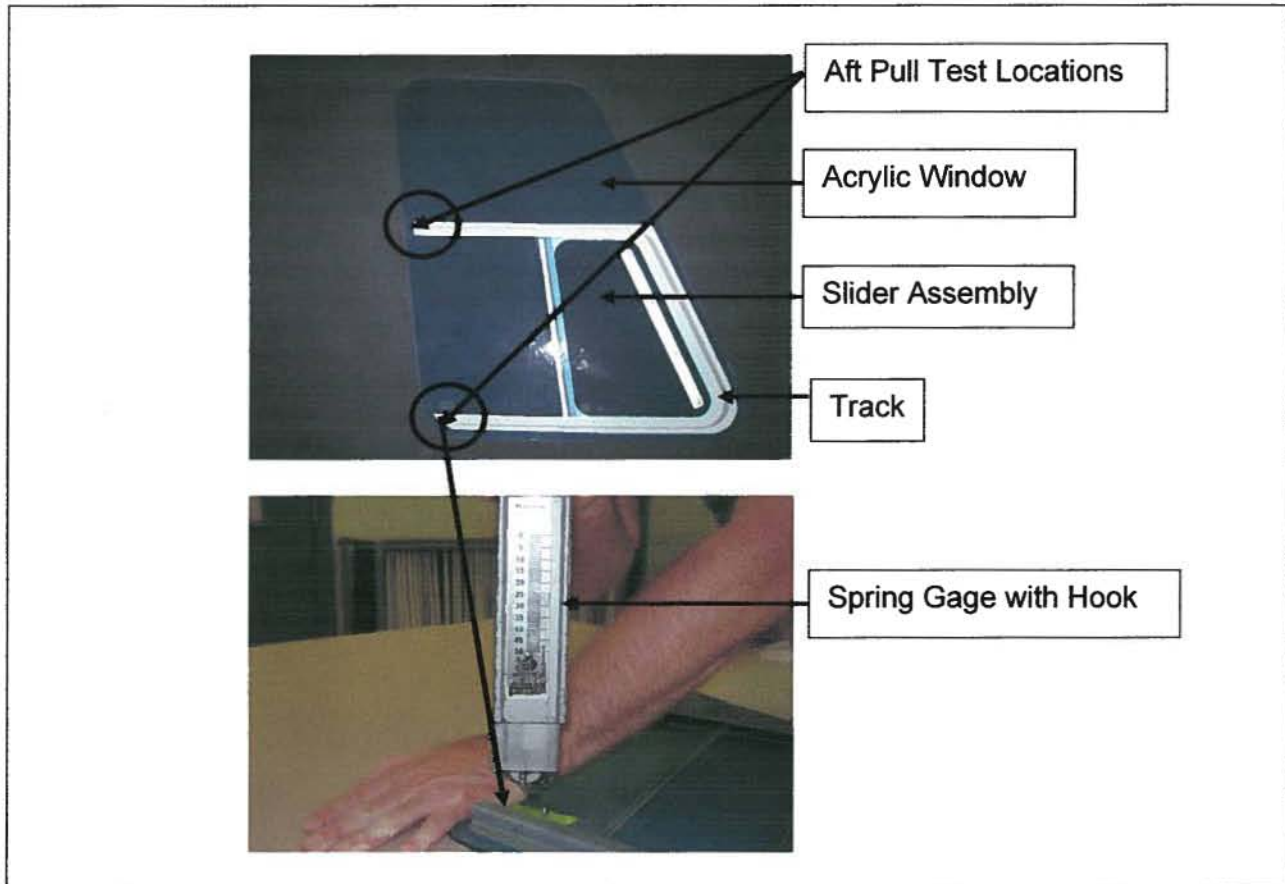
**FIGURE 3 – Aft Pull Test Locations**

1. With the slider assembly in the full-closed (fwd) position from the exterior of the aircraft using the spring gage, insert the hook directly into the channel of the slider track at the aft end of the slider (ref. Figure 3). Pull outward on the slider track (away from the acrylic) until the gage reads 25 lbs. Visually inspect track frame of slider for any obvious signs that the frame is de-bonding from the acrylic.

2. Repeat step 1 at second track location indicated in Figure 3.
3. With the slider assembly in the full-closed (fwd) position, from the interior of the aircraft, apply manual outward pressure at the two locations indicated in Figure 4. Visually inspect slider track for any obvious signs that the track is de-bonding from the acrylic.

6. Remove and replace any defective window with an airworthy window.
7. Annotate records to indicate compliance with Part II of this inspection.

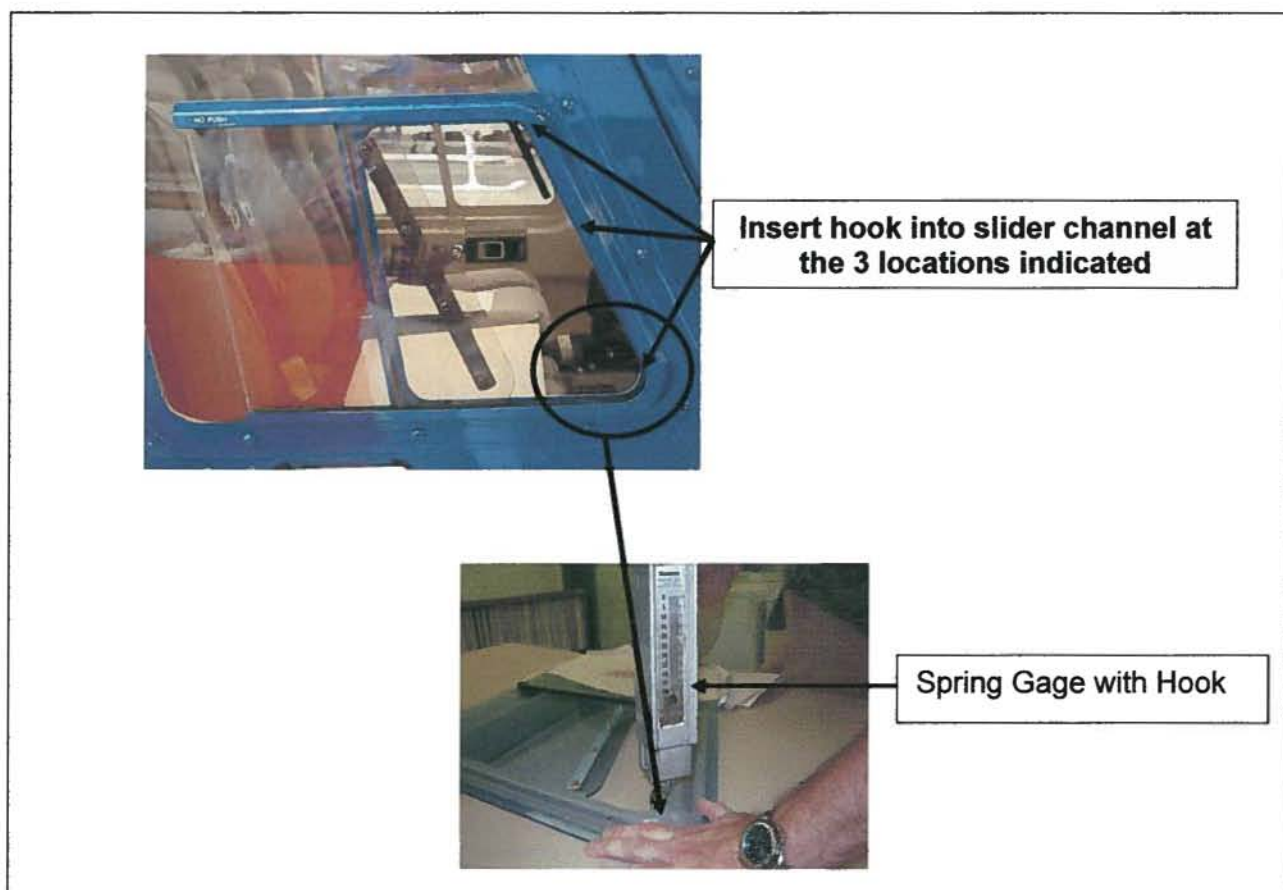
**FIGURE 5 – Forward Pull Test Locations**

4. With the slider assembly in the full-open (aft) position, from the exterior of the aircraft, insert the spring hook directly into the channel of the slider track at the 3 locations indicated in Figure 5.

5. Using the spring gage, pull outward on the slider track (away from the acrylic) until the gage reads 25 lbs. Visually inspect the slider track for any obvious signs that the track is de-bonding from the acrylic.
