AERONAUTICAL ACCESSORIES, INC.

Technical Bulletin TB No. AA-08098 No Revision

Bell Helicopter Vibration Monitor (BHVM) Kit
P/N 412-262-001* / 412-262-002*
*with SmartCycle+ Interface Kit installed,
P/N 412-261-006

**Bell Helicopter Vibration Monitor (BHVM) Kit with
SmartCycle+ P/N 412-262-003 / 412-262-004**

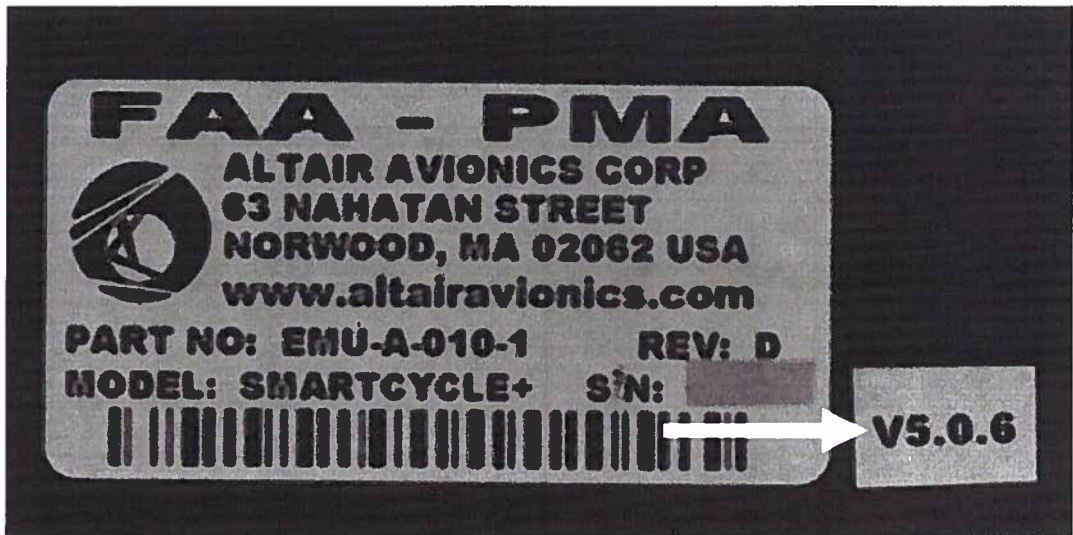
FIGURE 1 SOFTWARE VERSION DECAL

1. Locate the decal on the processor denoting the software version (Refer to Figure 1).
2. If the software version is V5.0.6, no further action is required. If the software version is V5.0.0 to V5.0.5, the processor can be returned for upgrade.

3. Refer to the Appendix for processor upgrade instructions.
4. Make an entry in helicopter historical records indicating compliance to this technical bulletin.

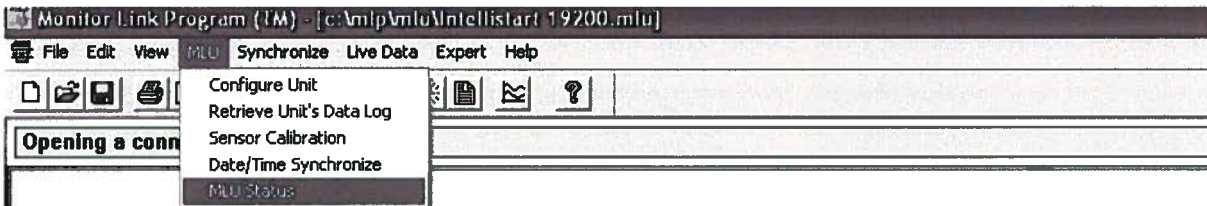
FIGURE 2 MONITOR LINK PROGRAM, MLU STATUS

4. Open the Monitor Link Program on the laptop and select Edit> Communication Port >Autodetect.
5. Once communication has been detected, on the tool bar select MLU> MLU Status (Refer to Figure 2).

6. Note the software version displayed on the top of the screen.
7. If the software version is V5.0.6, no further action is required. If the software version is V5.0.0 to V5.0.5, the processor can be returned for upgrade.

11. Refer to the Appendix for processor upgrade instructions.
12. Make an entry in helicopter historical records indicating compliance with this technical bulletin.
