ALERT SERVICE BULLETIN

AA-14108 Rev D

SUBJECT: GOODRICH EXTERNAL HOIST

Equipment/Furnishings - Load Check Inspection - Safety and Reliability

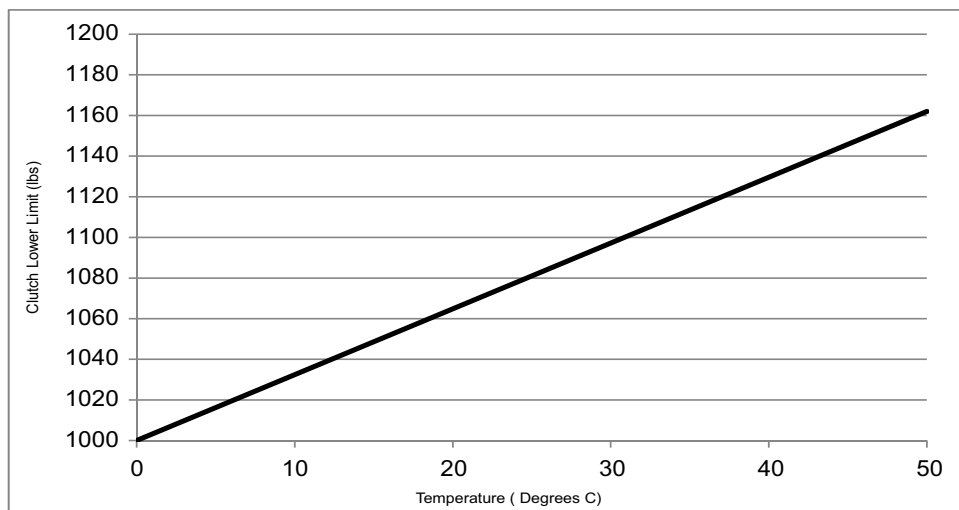
Figure 2. Lower limit for the 500 lb capacity hoists

TABLE 3. Lower Load Limit, 500 lb hoists
