ALERT SERVICE BULLETIN

ASB No. AA-03037

External Hoist Kits

Bell Helicopter Textron 206A,B,L,L-1,L-3,L-4, and 407 with the subject External Hoist Kit installed.

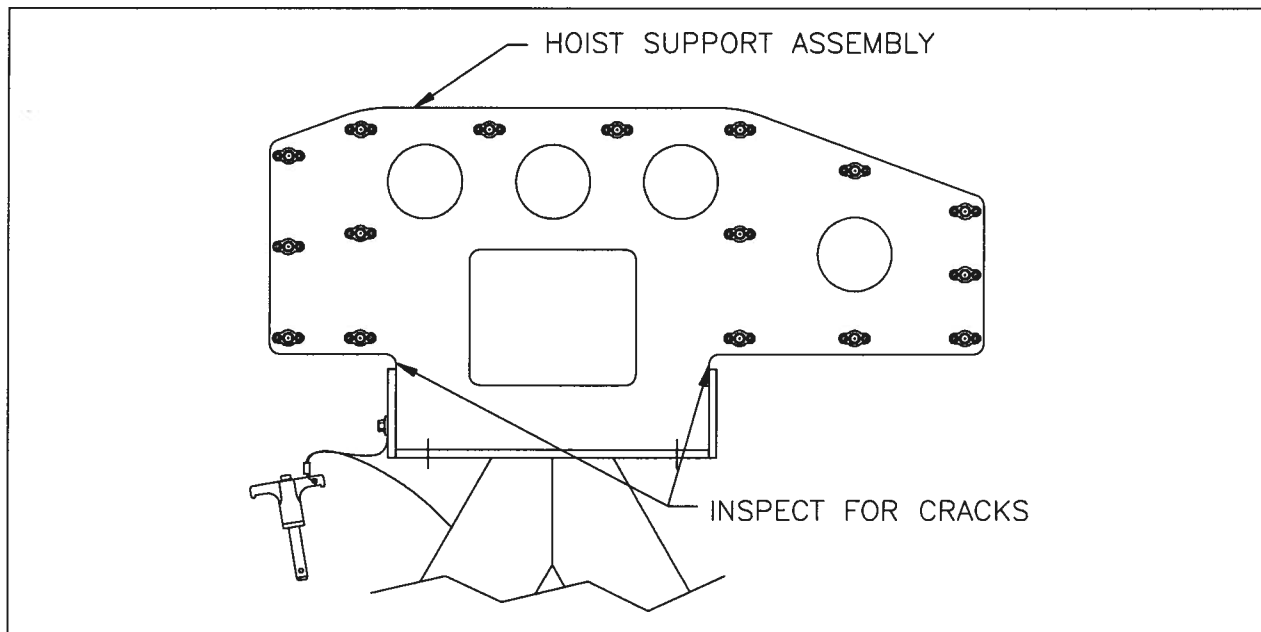
**FIGURE 1- HOIST SUPPORT ASSEMBLY INSPECTION**

This Alert Service Bulletin is being issued in response to an incidence of fatigue cracking of the fairing attachment point of P/N 206-992-110/-120 and 407-992-102 Hoist Support Assembly. This bulletin provides the procedures for inspection of the Hoist Support Assembly and identifies the appropriate modification of the part as necessary post inspection.

- 5.1.1 (If applicable) Remove Hoist Motor/Fairing/Support Assembly from helicopter.
- 5.1.2 (If applicable) Remove Faring halves from Hoist Motor/Support Assembly and retain hardware for later reinstallation.
- 5.1.3 (If applicable) Remove Hoist Motor from Hoist Support Assembly (P/Ns 206-992-110/-120 or 407-992-102) by removing the four ¼" bolts fastening the feet of the motor to the Hoist Support Assembly. Discard hardware. Place Hoist Motor in a secure dry place away from the work area.
- 5.1.4 Inspect Hoist Support Assembly for any sign of cracking in the plate areas directly above the weld fillet between the two small diagonal gussets and the back plate, as shown in Figure 1.

MAXIMUM ALLOWABLE DAMAGE AND REPAIR LIMITS (A crack may be repaired as noted in Section 6.0 REPAIR PROCEDURES, if it does not exceed these limits.)	DAMAGE TYPE
No Cracks	Type 1
Crack above one gusset not exceeding 1.3"	Type 2
Crack above one gusset exceeding 1.3" but less than 2"	Type 3
Cracks exceeding 2" or above both gussets	Type 4 No Repair allowed Replace Part

5.1.5 Determine **DAMAGE TYPE** as detailed in **Table 1 - DAMAGE AND REPAIR LIMITS** and proceed to the appropriate instructions as identified in **Section 6.0 REPAIR PROCEDURES**.
