ALERT SERVICE BULLETIN

ASB No. AA-03017

- SUBJECT:** External Hoist Kits
P/Ns 412-130-XXX, 412-140-XXX or 412-150-XXX
- MODELS AFFECTED:** Bell Helicopter Textron 412, 412EP, 412CF,
Agusta AB412, AB412EP with the subject External
Hoist Kit installed.
- COMPLIANCE:** This bulletin shall be complied within 50 flight
hours of receipt.
- DESCRIPTION:** This Alert Service Bulletin is being issued in
response to an incident of electrical interference
with basic aircraft equipment (i.e. AHRS Gyro,
Generator, instruments, etc). This bulletin
provides the procedures and identifies the
materials required to accomplish a modification to
improve electrical bonding to preclude electrical
interference. This document is FAA/DER
approved.
- MANPOWER:** Approximately 2.0 hours.

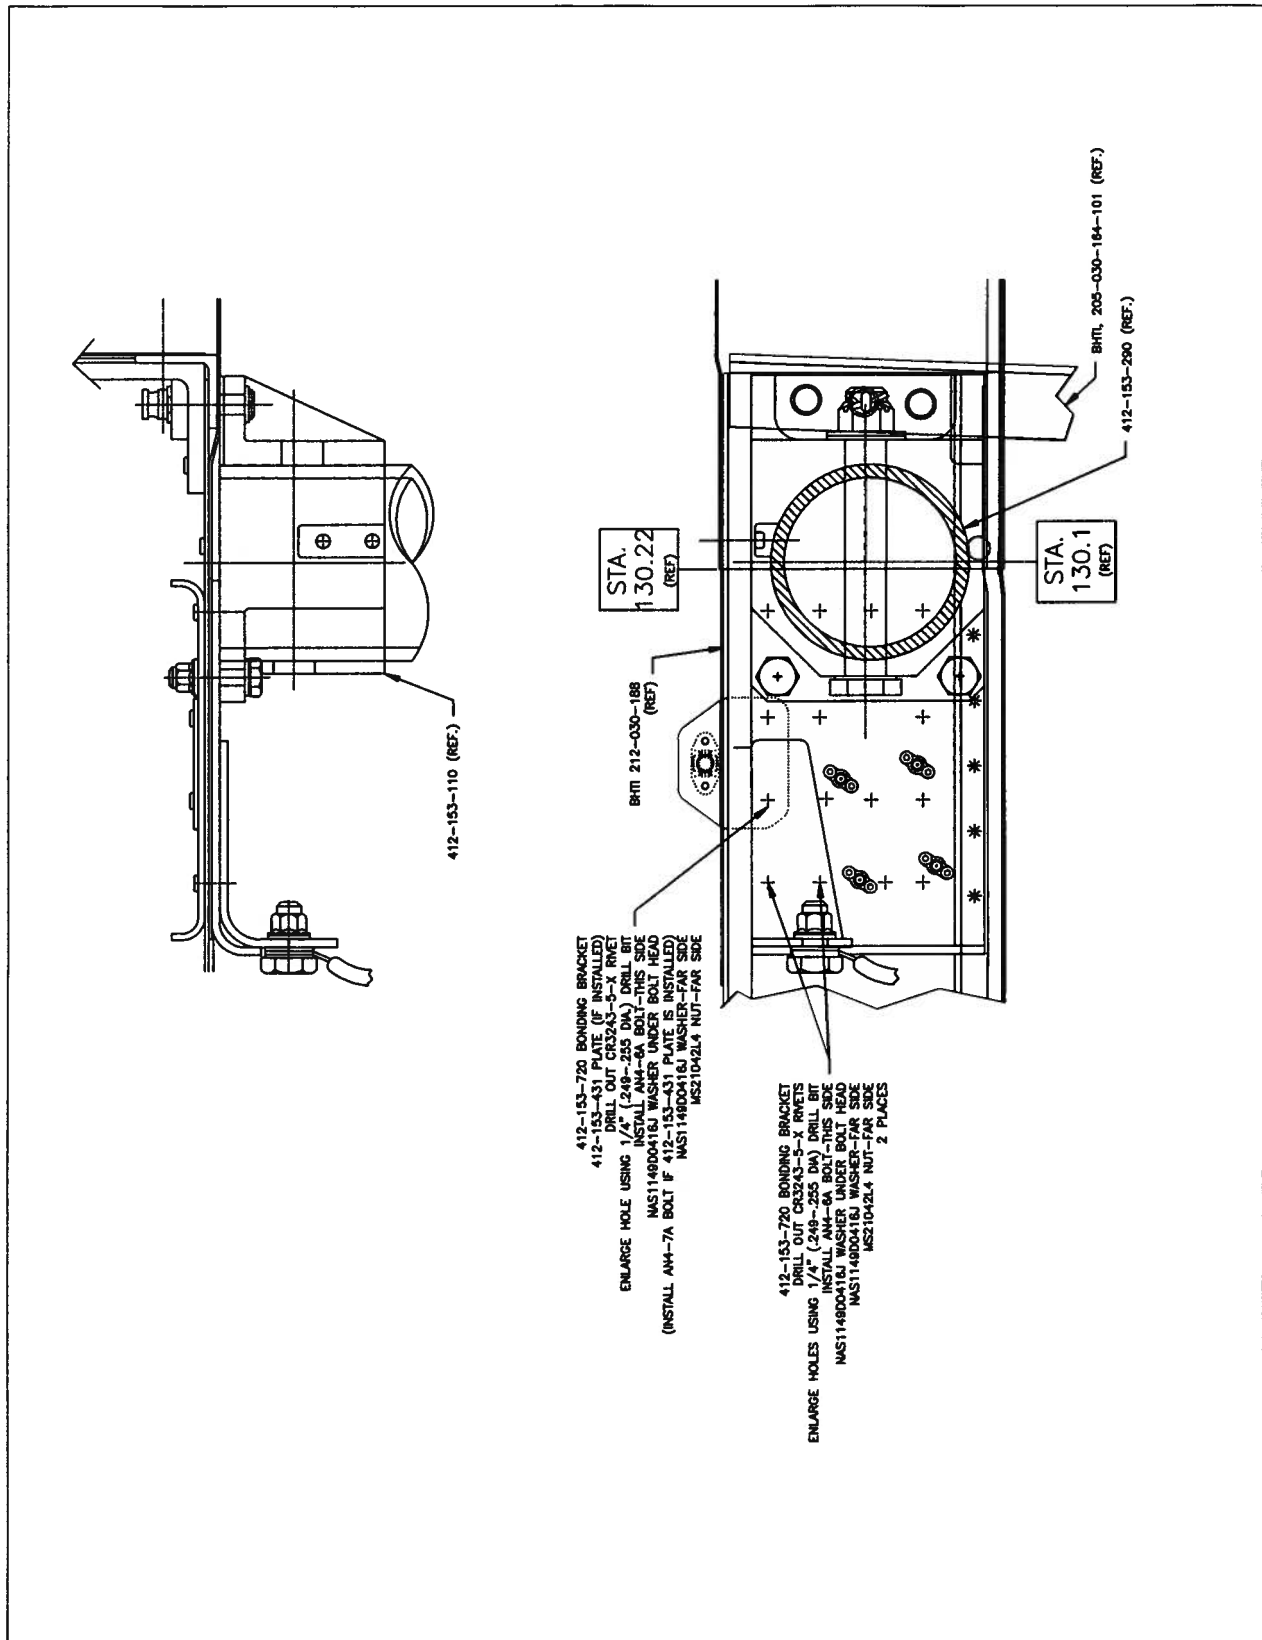
Figure 1

1. Locate Bonding Bracket (412-153-720) as shown in Figure 1.
2. Remove any existing blankets or trim to gain access to the area. Retain for reinstallation.
3. Drill out the three rivets attaching the Bonding Bracket to the airframe (Ref. Figure 1).

4. Increase the diameter of the three remaining holes by using a 1/4" (.249-.255 dia.) drill bit.

5. Using 100 grit sandpaper or dual action sanding, incrementally remove up to a maximum of .005 from the backside of the Bonding Bracket. Wipe the exposed surface with clean cheesecloth. The cheesecloth shall be either dry or wetted with isopropyl alcohol.

6. Apply a coating of chemical conversion coating (MIL-C-81706, Class 3 or equivalent) to the bond surface using a nonmetallic brush. Allow coating to remain on bond surface for 5 seconds maximum. This produces a light iridescent yellow finish on the bond surface.
7. Remove excess chemical conversion coating from the bond surface by blotting with a clean dry cheesecloth. Allow the bond surface to air-dry or gently wipe bond surface with cheesecloth.
8. Install Bolts, Washers and Nuts as shown in Figure 1.
