ALERT SERVICE BULLETIN

ASB NO. 99075 NO REV. • DATE: JUNE 18, 1999 • PAGE 1 OF 7

SUBJECT: **HOIST SUPPORT INSTALLATION, LUCAS
WESTERN HOIST;
P/N 412-142-300/-350/-400**

HELICOPTERS AFFECTED: All Bell 205A-1, 212, 412, 412EP helicopters equipped with subject Hoist Support Installation.

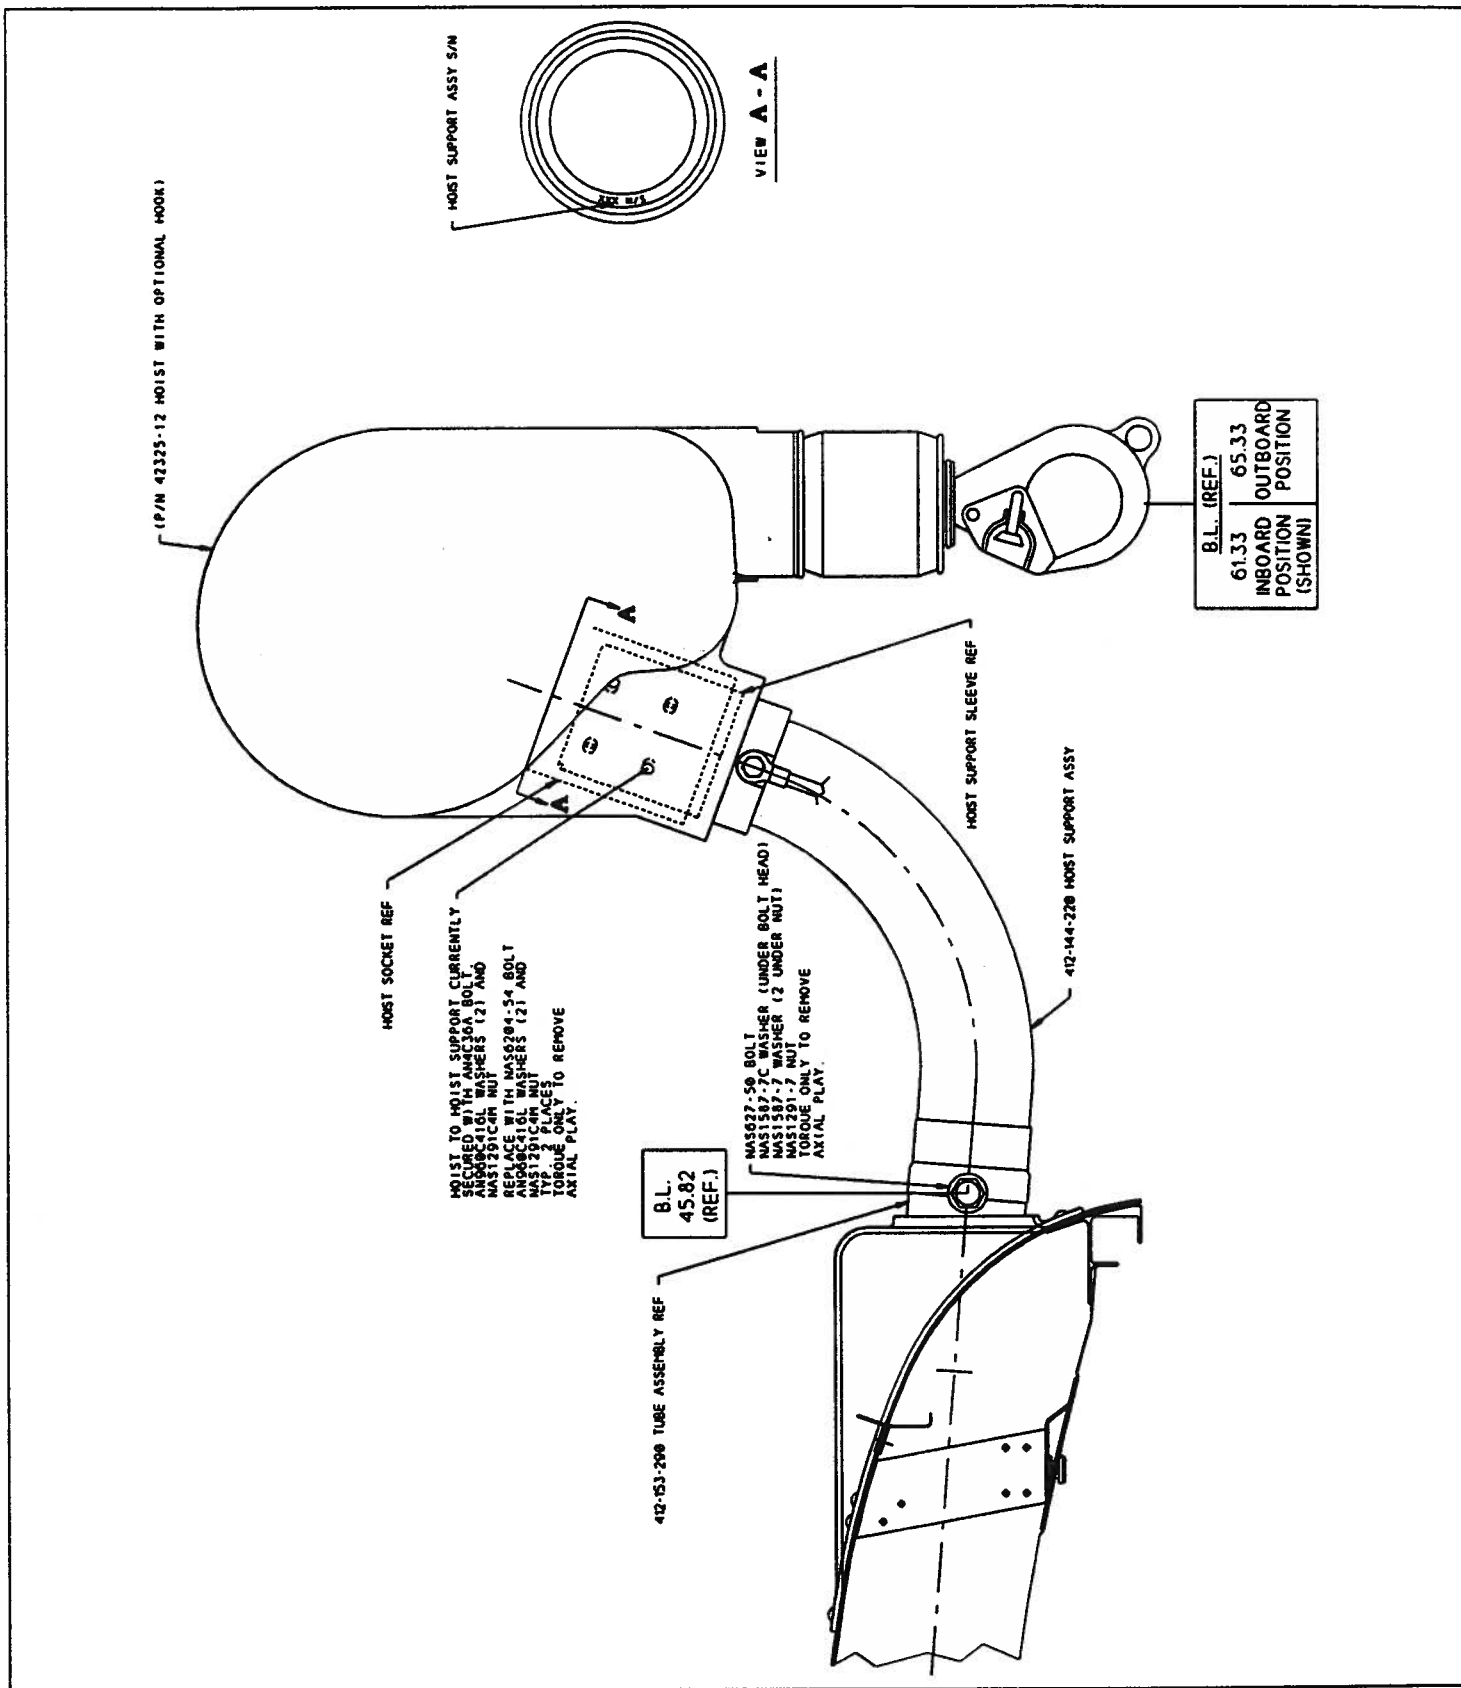
Figure 1

DESCRIPTION: During routine inspection of a Lucas Western External Hoist System installed on a 412 helicopter, it was discovered that one of the AN4C36 Bolts used to attach the Hoist to the Hoist Support Assembly had failed. Engineering investigation indicated that the head of the bolt was sheared due to fatigue. The redundant design of the Hoist Support Installation allowed the Hoist to function normally with only one of the two attachment bolts in place. This Alert Service Bulletin gives instructions to replace the current two AN4C36 Bolts used to attach the Hoist to the Hoist Support Assembly with increased strength NAS6204-54 Bolts. This Bulletin also gives instructions for Sealant installation between the Hoist Socket and Hoist Support Sleeve to dampen vibration.

2. Remove the Bolt (NAS627-50), Nut (NAS1291-7) and Washers (NAS1587-7C, under Bolt head), (NAS1587-7, two under Nut) securing the Hoist Support Assembly (412-144-220) to the Tube Assembly (412-153-290). Refer to Figure 1. Discard the Nut and retain the hardware remaining for reinstallation.

7. Slide the Hoist Support Assembly out of the Hoist Socket. Record Hoist Support Assembly Serial Number (location shown in Figure 1) in appropriate section of Appendix A.

8. Clean the Hoist Socket and Hoist Support Assembly Sleeve with Isopropyl Alcohol.
9. Apply a thin (1/16 inch) layer of Sealant (MIL-S-8802 TY2 CL 1/2), provided, to the inside diameter and top of the Hoist Socket.

10. Slide the Hoist Support Assembly into the Hoist Socket and install the new Bolts (NAS6204-54), Nuts (1291C4M), and Washers (AN960C416L) provided.
11. Clean up any Sealant squeeze out with Isopropyl Alcohol.
