ALERT SERVICE BULLETIN ASB No. AA-06179

Revision A

Emergency Pushout Window

Bell Helicopter Textron model 407 with

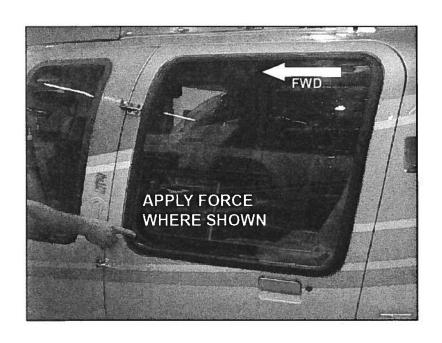
FIGURE 9 - INGRESS VERIFICATION TEST

- 2. If the window cannot be dislodged within the specified force range, verify sealant application is as specified in Section 5 and Figure 5. Verify the seal lock is installed correctly as specified in Section 5, and that there is no evidence of binding between the seal, door and window. Inspect the upper interior door trim panel to verify the edge contacting the seal is adequately trimmed and not impeding the seal's function as specified in Step 1. Correct any discrepancies, if found, and repeat Step 1; otherwise proceed to Step 3.
- 3. If the window is dislodged with 45 60 lbs of force applied, continue to Step 4.
- 4. With a thin flat object, carefully reinstall the corner of the window in the seal ensuring no permanent damage has occurred to the seal, window or door frame. Continue with pushout window installation verification

- 8. Repeat Steps 1 thru 7 for the opposite window verification test (see Figures 2 thru 4, and 7 thru 10).

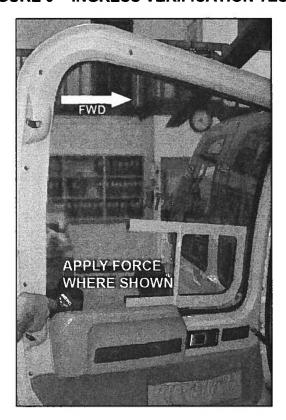
FIGURE 10 - EGRESS VERIFICATION TEST

- 6. If the window cannot be dislodged within the specified force range, verify sealant application is as specified in Section 5 and Figure 5. Verify the seal lock is installed correctly as specified in Section 5, and that there is no evidence of binding between the seal, door and window. Correct any discrepancies, if found, and repeat Step 5; otherwise proceed to Step 7.
